**SITE PLAN REVIEW APPLICATION
FOR
SKI AREA EXPANSION – PHASE 1**

THE BALSAMS PLANNED UNIT DEVELOPMENT
DD – RESORT

UNINCORPORATED PLACES OF COÖS COUNTY NH

Supplemental Information for 2/15/2023 Meeting

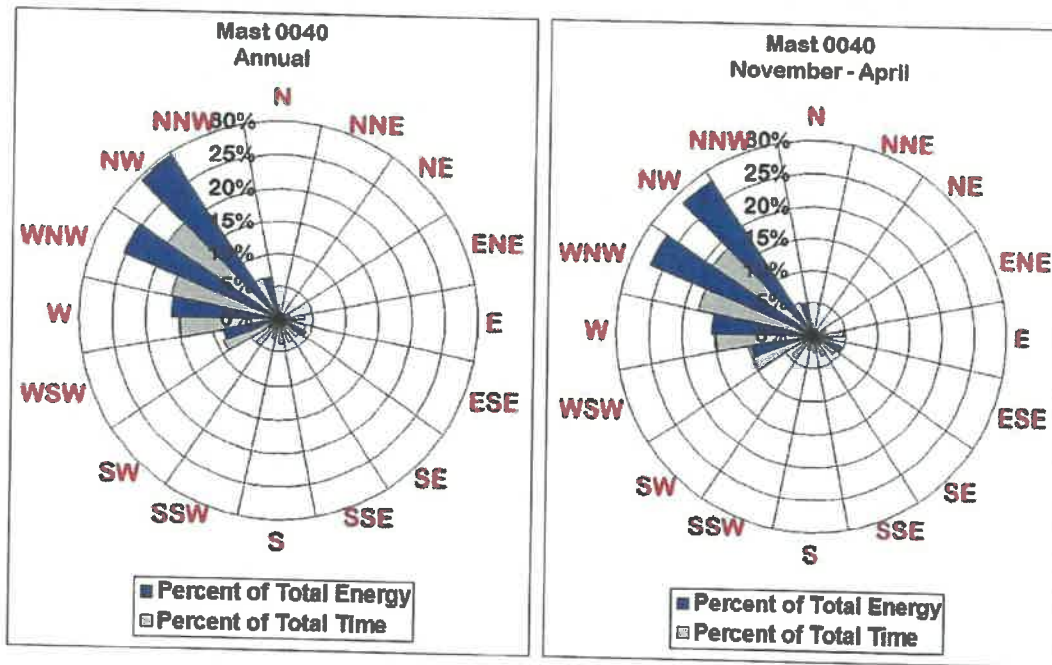
Figure 2. Granite Reliable Mast 0040 Annual and Icing Season Wind Roses

The annual wind frequency and energy by direction plot (wind rose) for Mast 0040, one of the previous on-site masts with more than two years of data, is presented below in Figure 2. Also plotted in this figure is the wind rose from the same mast for the icing season, defined as the months of November through April. The wind rose indicates a predominant west-northwest to northwest wind flow, which is dictated both by the site's high elevation and the directional orientation of the ridgeline that the project is built on. The annual and icing season wind roses are similar and indicate that approximately 70% of the energy available from the wind is observed in the west through northwest direction sectors.

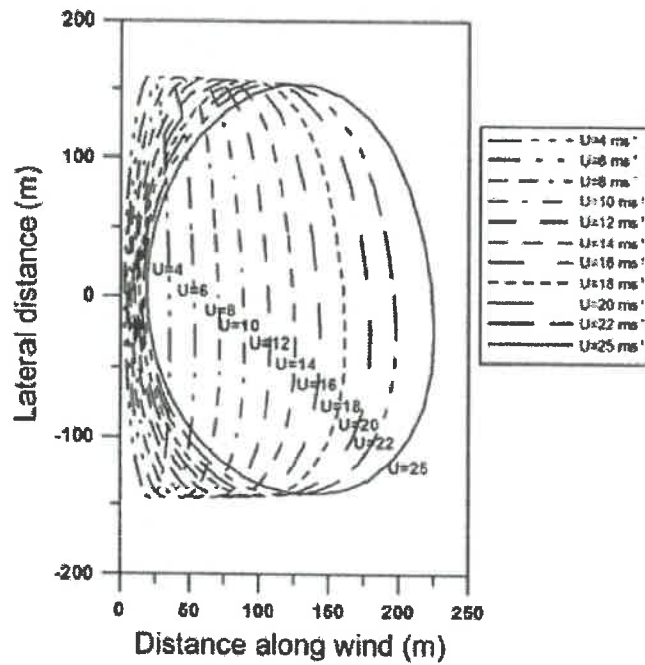
Figure 6. Simulated impact locations for ice fragments released from the blade tip at different blade positions, for different hub height wind speeds (from Biswas et al., 2011).

Figure 6 shows the general pattern of ground strike locations for ice fragments ejected from the blade tip at different rotational blade locations. The pattern approximates an oval, with all ice spreading laterally downwind of the turbine. The width of the oval depends on the hub height wind speed, with stronger speeds transporting fragments further downwind. The ice striking the ground closest to the turbine occurs when the blade is near the bottom of its rotation. The farthest flights of ice occur when the blade is rotating upward within $30\text{-}45^\circ$ of horizontal; these fragments land downwind and off to the side of the turbine but not directly downwind.
